## **SANITARY SURVEY REPORT**

**Cuba Water System  
NM3509023**

**RECORD OF INSPECTION**

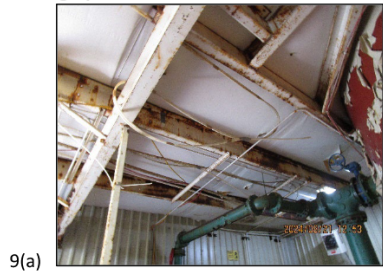
**9.** On the day of the sanitary survey, it was observed that the overall condition of the building, equipment, and controls at Treatment Plant #1 (#09023004) is greatly in need of maintenance. Excessive humidity within the building has led to corrosion of most exposed metal surfaces, peeling paint on the exterior of the filter, and corrosion of the electrical control panels used to operate plant equipment. Water used for process control monitoring is flowing directly onto the floor contributing to the excessive humidity in the building. The poor housekeeping at Treatment Plant #1 (#09023004) presents potential for workplace hazards for water system staff, equipment failure, and water outage.

**10.** On the day of the sanitary survey, it was observed that the Main Booster Station (#09023007) and surrounding security fence was damaged and poorly repaired. The booster station building had several open penetrations that could allow insects and vermin to enter the structure. An old wooden sign was used to patch the building after a vehicle collision. The building also lacks proper insulation to prevent pipes from freezing during the winter.

9) Proper ventilation has been installed to reduce humidity within the plant building, that peeling paint on the filter has been removed and repaired or repainted, that process control monitoring water is routed to the drain rather than spilling onto the floor, and that areas with exposed corroded metal have been painted, coated, or repaired to prevent further corrosion.

10) The open penetrations in the Main Booster Station (#09023007) building have been properly repaired to prevent the entry of insects and vermin and that the building is properly insulated to prevent pipes from freezing in the winter. Additionally, the security fence surrounding the Main Booster Station (#09023007) must be repaired.
